Risk Case Study: Condo HVAC Issue

Project Overview

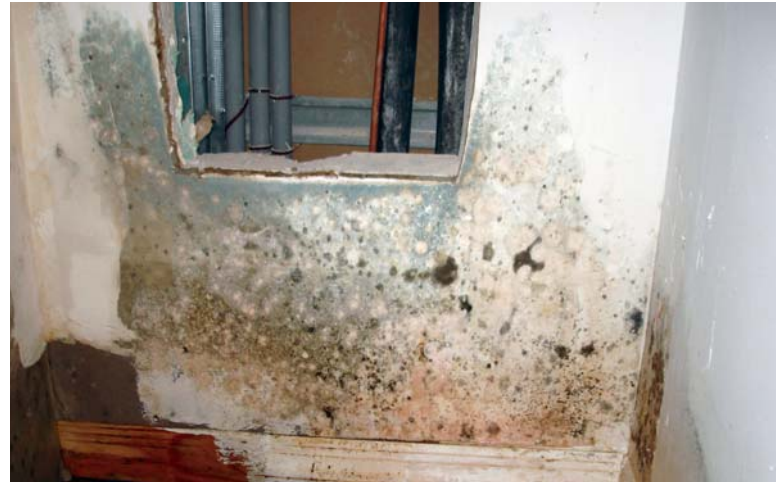
(Above) Mold and other water damage found in most affected units. (Below) New, correctly-sized air conditioning units addressed key remediation issues.

- + Over-sizing of air conditioning units resulted in operation not meeting space demands.
- + Lack of adequate humidity control – AC units were short-cycling and not removing humidity.
- + Poor air sealing of penetrations occurred between living spaces and common shafts.
- + Empty units within the building created varying ambient interior conditions.
- + Different compass orientations created different sun, shading and temperature profiling around the building.
- + Living units were of five different configurations.
- + Humid air from bathrooms, dryers, etc. was not being exhausted properly.

- + Smaller air conditioning equipment was installed to better match the individual unit loads.
- + A stand alone dehumidification unit was placed in each condo to better control interior space humidity levels and distribution balance between rooms.
- + Air conditioning ducts were sealed.
- + A rooftop fan was installed on the common bath exhaust shaft to promote better removal of high humidity air from all bathrooms.

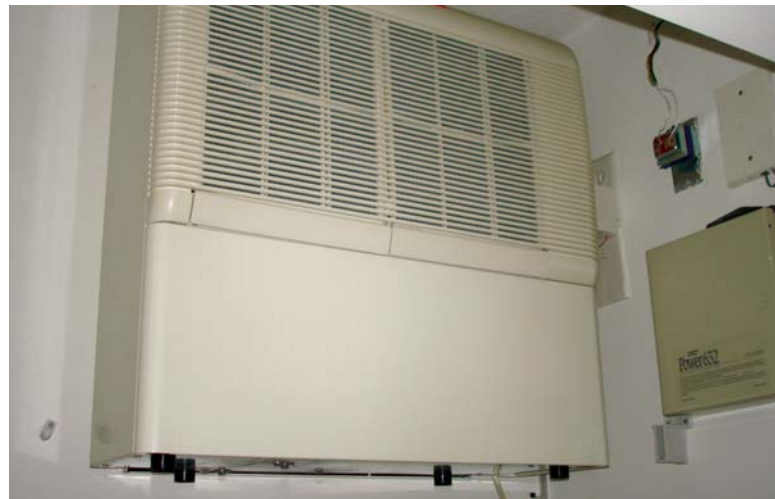
(Above) New dehumidifiers such as this one were installed in all units to avoid future risk.
